# Certificate of Validation

## Powder Coating Cure

| Certificate Details | |
|---|---|
| Process: | Powder Coating Cure |
| Standard: | ISO 2360 / Qualicoat |

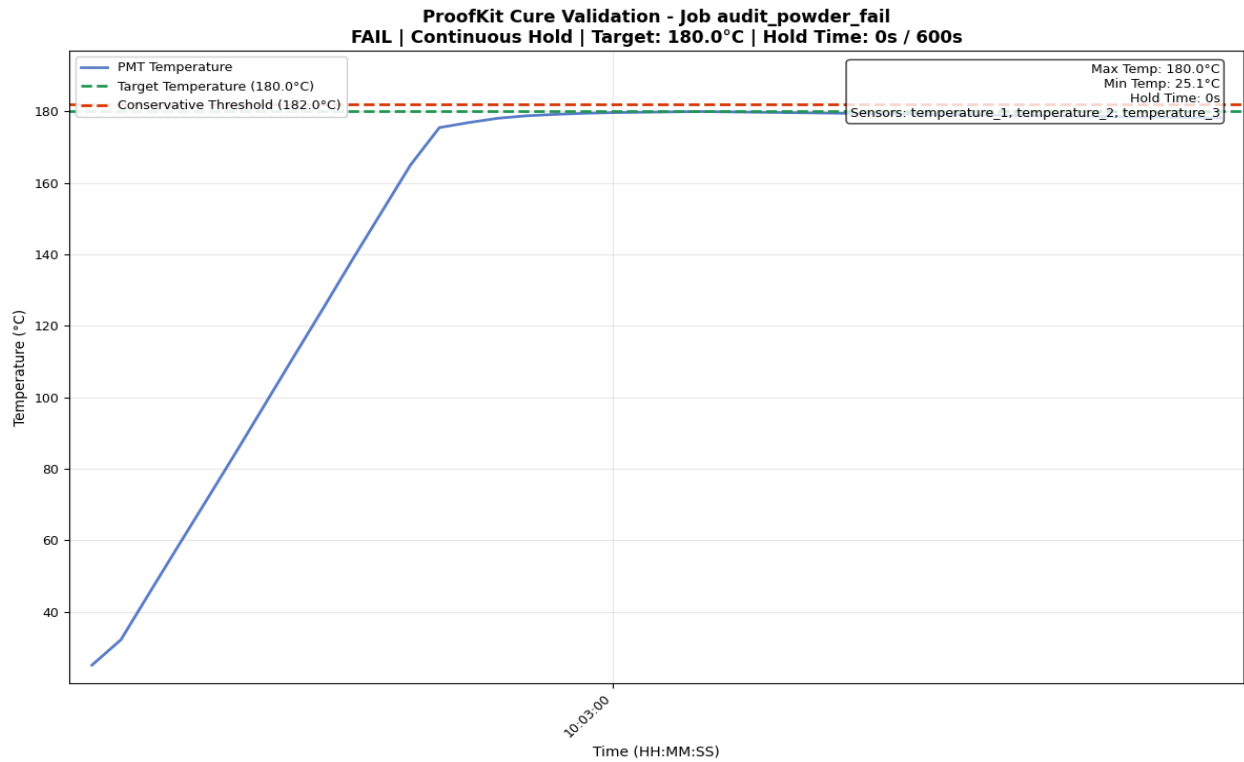
## Temperature Profile

This process has FAILED to meet the requirements of ISO 2360 / Qualicoat. Critical parameters were not achieved. The process requires adjustment and revalidation. See metrics table above for specific failures.
